Precast concrete bridge barriers for accelerated bridge construction

Major: Civil Engineering (Structural Engineering)

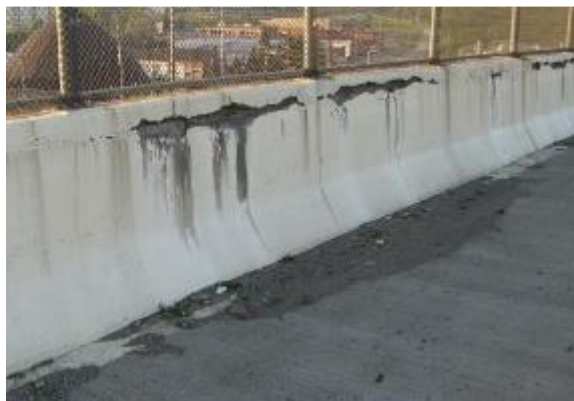
Figure 1.1 Cast-in-place barrier requiring maintenance (*Courtesy of T. Capuano*)

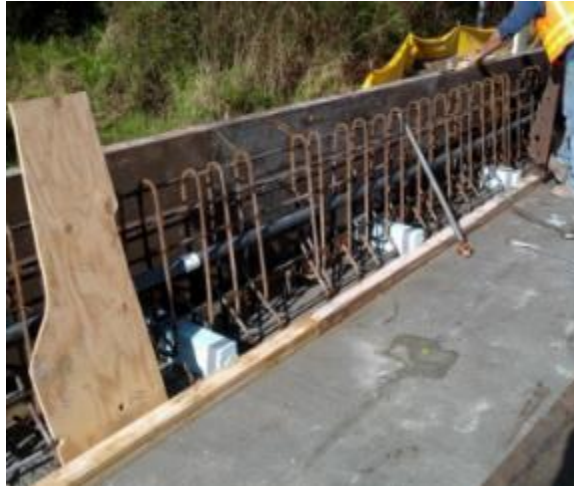
Figure 1.5 Rock Ridge Road barrier after adding additional reinforcing (*FDOT 2014 Design Training Expo*)

in-place. A portion of the rebar was built into the deck slab unit, Figure 1.4, and bent to be integrated with the concrete barrier reinforcing as shown in Figure 1.5.

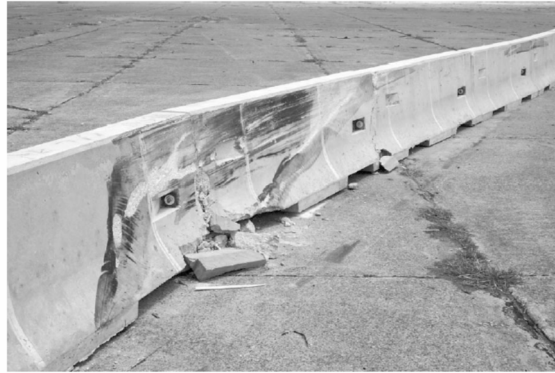
Figure 2.12 Damage to 10-ft long prefabricated barrier with X-Bolt connections (*TTI, 2005*)

The barriers had a standard F-shape profile and were 32 inches in height. The cross bolts used a 7/8-inch diameter threaded rod and were 25-1/4 inches and 29 inches in length. The cross-bolt barriers were tested under TL-3. There were two crash tests conducted. One test consisted of 20, 10-foot long concrete barrier sections for a total test installment length of about 200 feet. A 4960 lb pickup truck was used for the crash test. The resulting damage is shown in Figure 2.12. Some permanent deformation of the connection bolts was noticed when disassembling the barrier. The barrier system experienced 27.0 inches of maximum deflection.

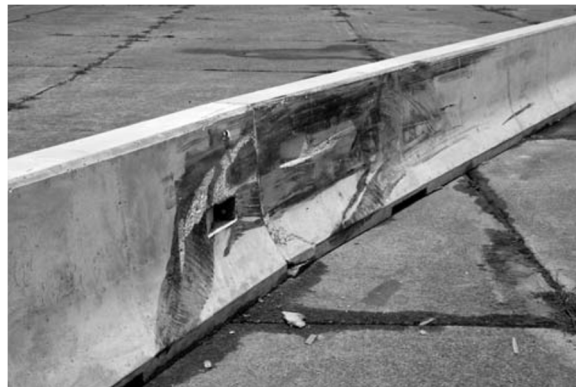
Figure 2.13 Damage to 30-ft long precast barrier with X-Bolt connections (*TTI, 2005*)

The second test had the same barrier and connection details, but the test installment included seven 30-foot barrier segments for a total length of about 210 feet. The pickup truck used for this experiment was 4531 lbs. The damage resulting from the vehicle impact is shown in Figure 2.13. After the test, the connection bolts could easily be removed and possibly reused. The maximum deflection experienced by the system was 19.0 inches.

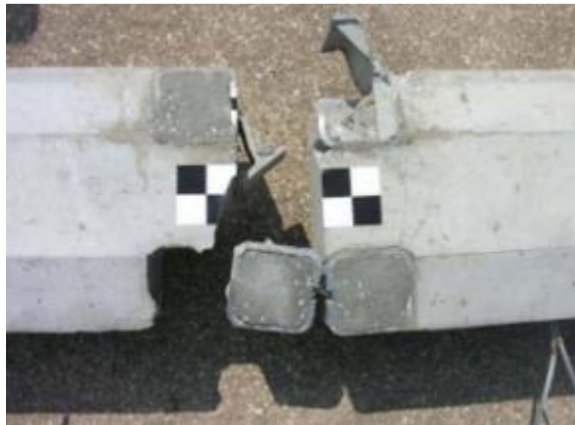
Figure 2.17 Failed MWRSF I-Shaped rail connection (*MWRSF, 2012*)

The first tested connection used I-shaped steel segments to connect the rails. The I-shaped sections were placed inside steel pockets that were filled with grout. This is illustrated in Figure 2.15. During the test, the joint failed and the rail segments completely separated. The connection was able to resist a force of 143 kips, exceeding the design forces needed for TL-4. The test connection and the failure of the connection are shown in Figure 2.16 and Figure 2.17, respectively.

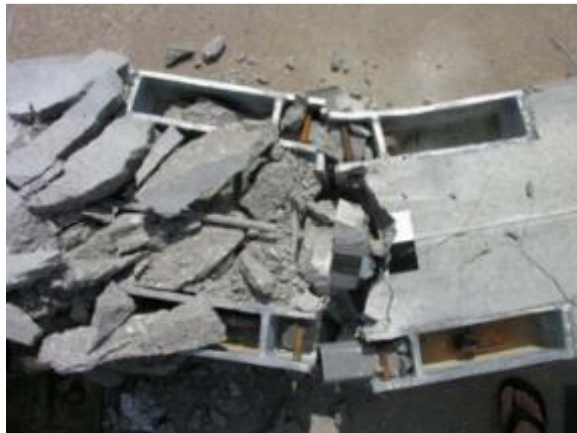
Figure 2.19 Side bolt and shear tube connection failure (*MWRSF, 2012*)

The second tested connection used two bolts and two shear tubes to connect the adjacent rails. During this test, the rails stayed connected, but the joint was severely damaged. The concrete between the steel pockets completely broke apart. The connection was able to resist a force of 102 kips, exceeding the design force of 54 kips needed for TL-4. The test connection and the failure of the connection are shown in Figure and Figure , respectively. After these experiments were conducted, the results were analyzed, and they were redesigned according to their failures.

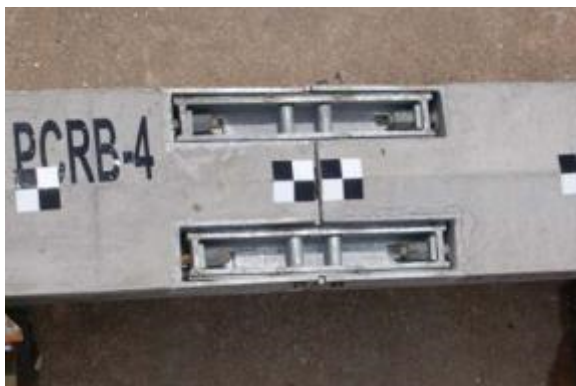
Figure 2.24 Side bolts and shear tube connection improvements (*MWRSF, 2012*)

The side bolt and shear tube connection were modified in a similar fashion. The longitudinal steel size was increased to a threaded no. 8 bar, the steel tubes were cut to form U-shaped pieces, the size of the joint pockets increased, and shear bolts were added. See Figure 2.24 below. The testing results of this joint proved that the connecting threaded rods were too weak and failed at a load just over 60 kips. Resulting damage is shown in Figure 2.25.

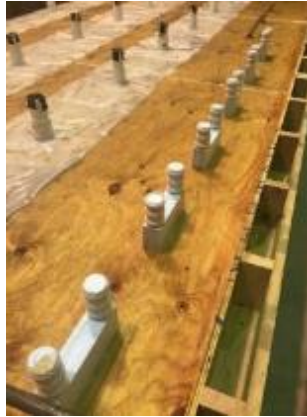
Figure 4.8 Deck block outs to facilitate U-bar installation

As noted, the u-bars for the PBU connection are inserted from the underside of the overhang into pockets in the bridge deck. Cutouts were made, and proper blockage was established before pouring the deck concrete. The block outs of these access pockets are shown in Figure 4.8.

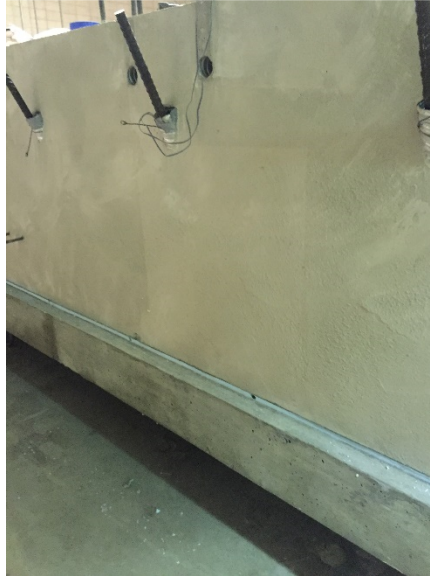
Figure 4.21 Foam added to grout pad to minimize damage cover concrete

After the bars were in place, the grout pad between the overhang and the barrier was poured. In this case, the grout pad had a depth of three-quarter inch. Also, a foam was placed under the barrier three quarter inches from the back side to limit the damage to the barrier during the push test, shown in Figure 4.21.

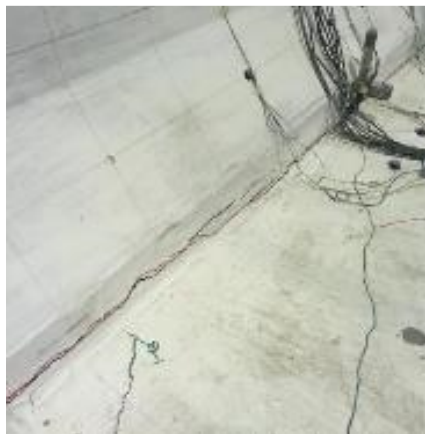
Figure 5.12 Crack at the barrier to deck interface in PBU during Test 2

The first three intervals, up to 18 kips, performed very similar to the response of PBI in Test 1. New deck cracking began around 18 kips. At this point, the barrier was deflected 0.164 inches. At 24 kips, a crack became visible along the entire length of the grout pad between the bottom of the barrier and the top of the bridge deck, see Figure 5.12. The existing cracks continued to widen up until about 36 kips. Some softening in the system was observed when the load was about 36 kips and the barrier began to experience large displacements. The test was paused and unloaded after the barrier deflection reached 0.8 inches.

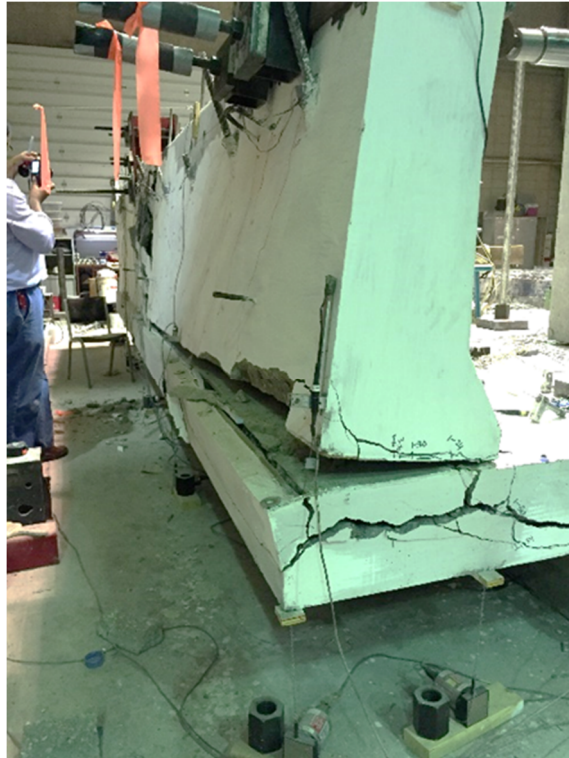
Figure 5.34 Damage to barrier and deck after Test 5 pull test
